Manual for Dismantling, Documenting and Rebuilding Historic Tiled Stoves

—Sustainable Heritage Report No. 3

A joint project between Gotland University, Estonian Academy of Arts
and Novia University of Applied Sciences.

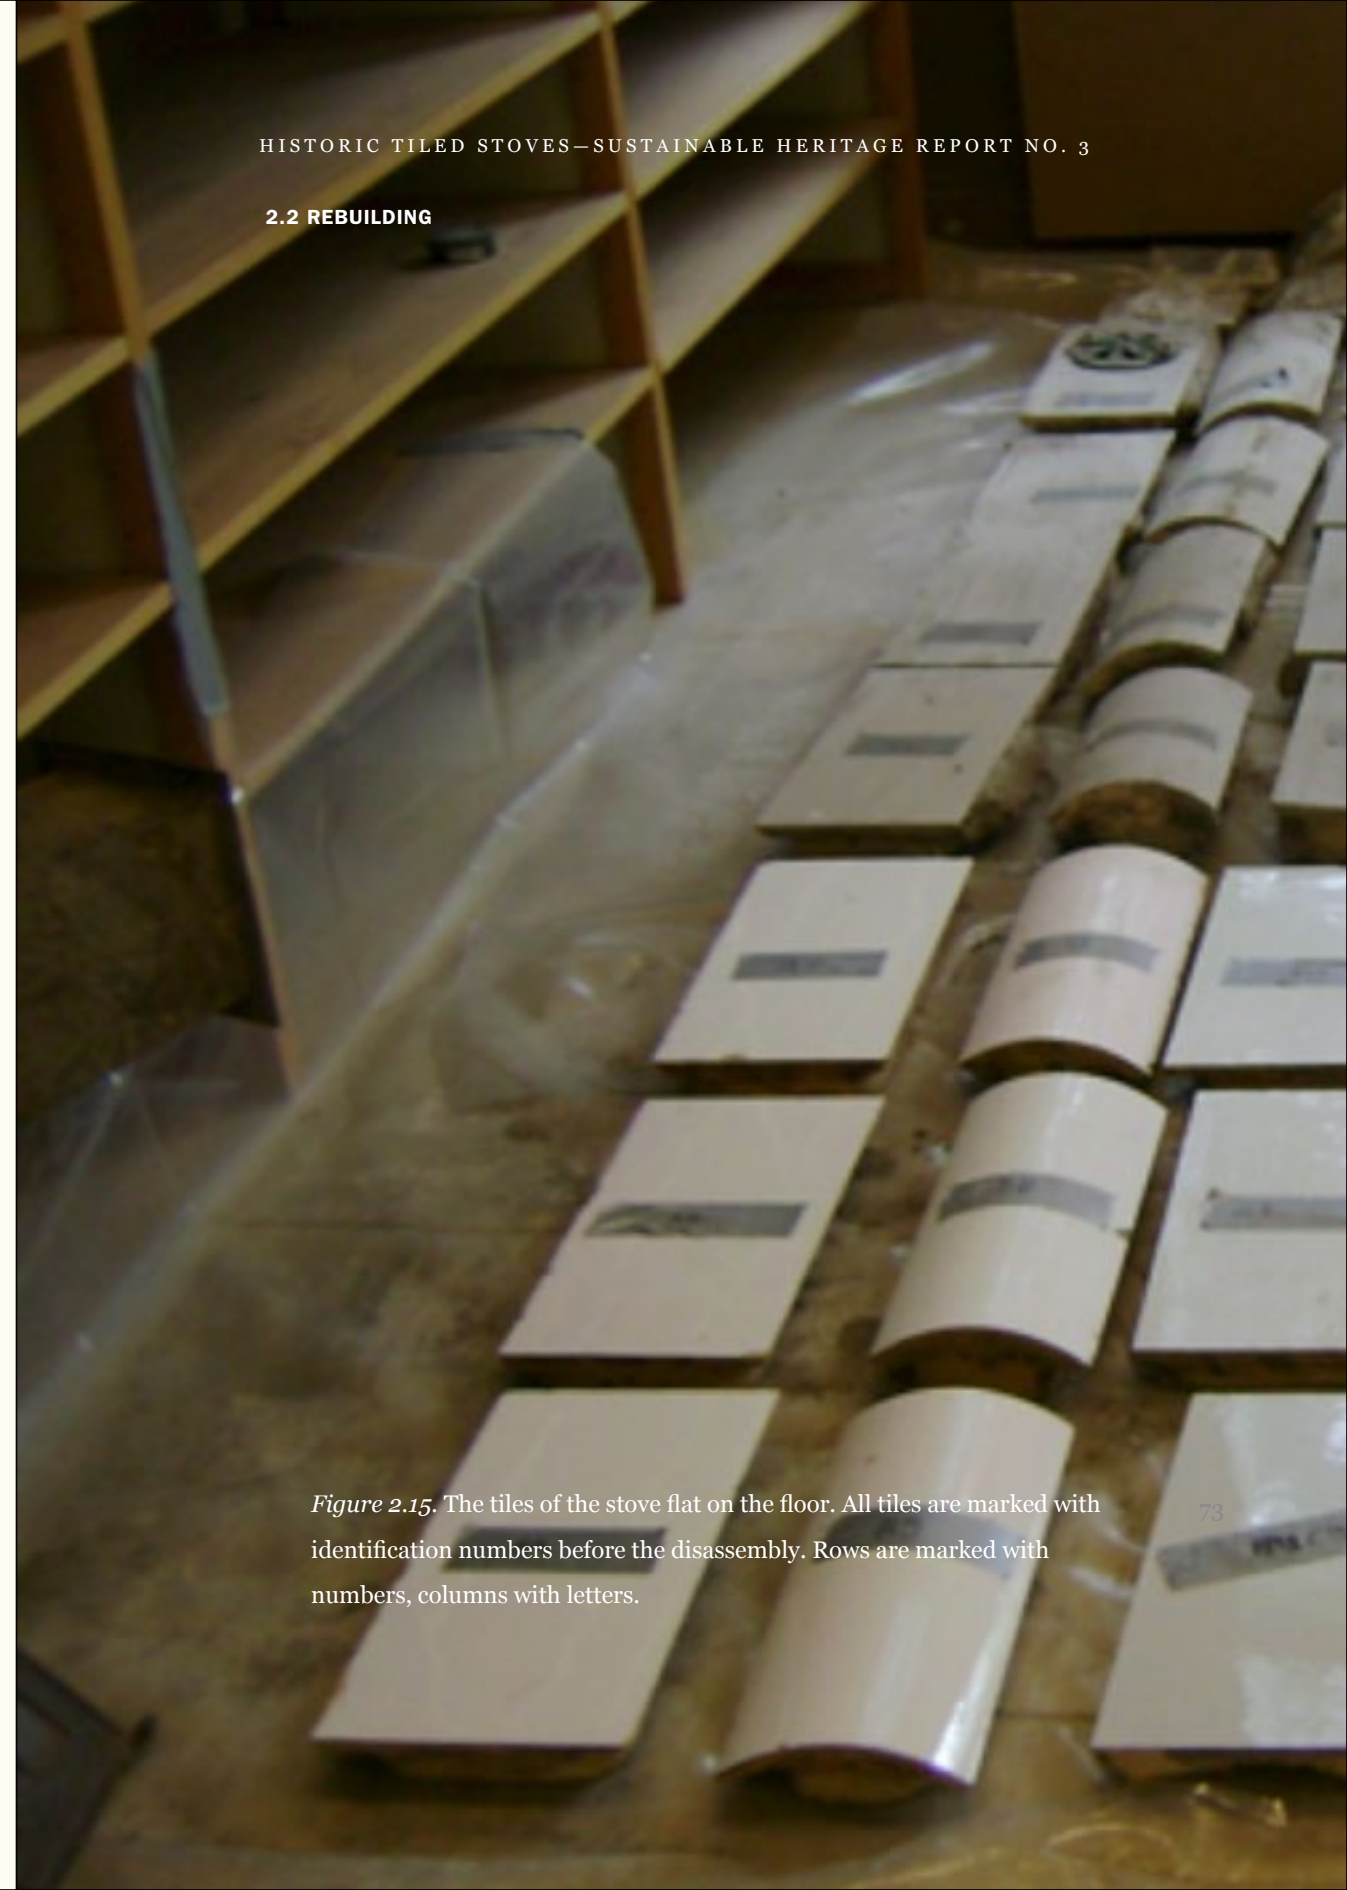
Figure 2.15. The tiles of the stove flat on the floor. All tiles are marked with identification numbers before the disassembly. Rows are marked with numbers, columns with letters.

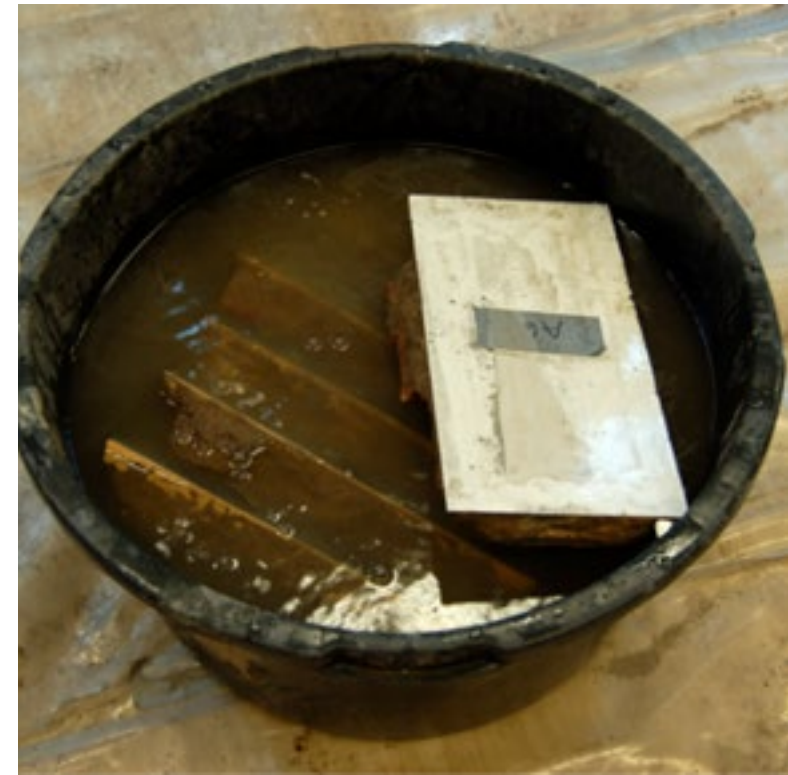
Figure 2.17. The rebuilding of the stove started with removing the mortar from the tiles and the thin bricks in the cavity on the back of each tile. The tiles are sunken in water for about half an hour in order to soften the old mortar before they are washed and cleaned. This is why it is important to use clay mortar: cement would not dissolve in water and the tiles would crack if they were cleaned with force.

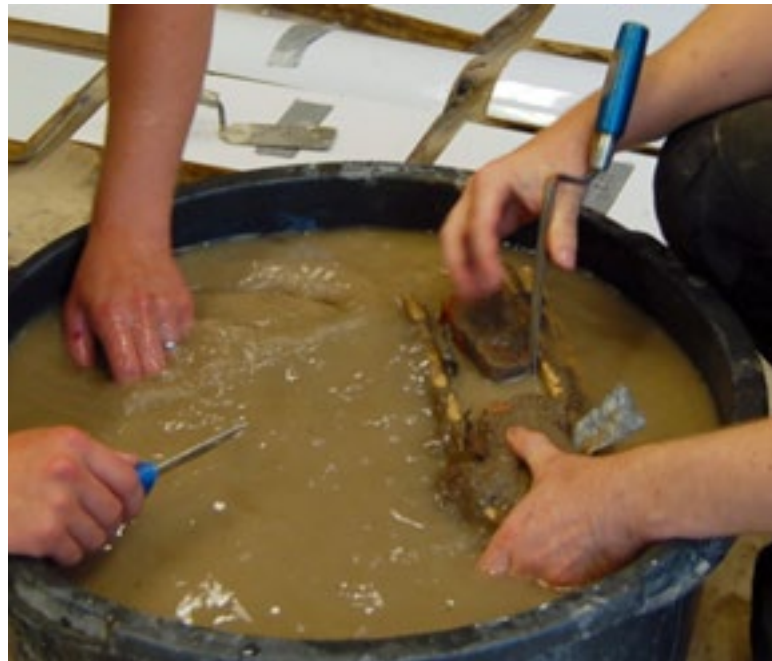
Figure 2.18. The bricks, the metal clamps and mortar on the backside of the tiles are being removed. This takes time and you have to be patient because the edges and corners chip easily. Traditionally also the metal parts were reused but we ran out of time for that.

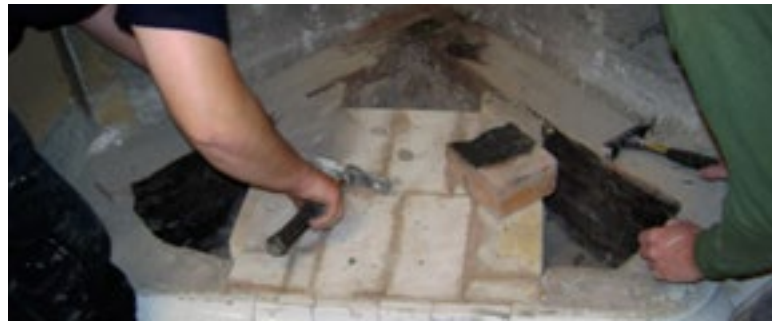
Figure 2.21. This is where we started the rebuilding of the stove. The bottom two rows of tiles were already in place (they were intact and therefore not dismantled). Before laying new bricks the base had to be cleaned and the old mortar removed.

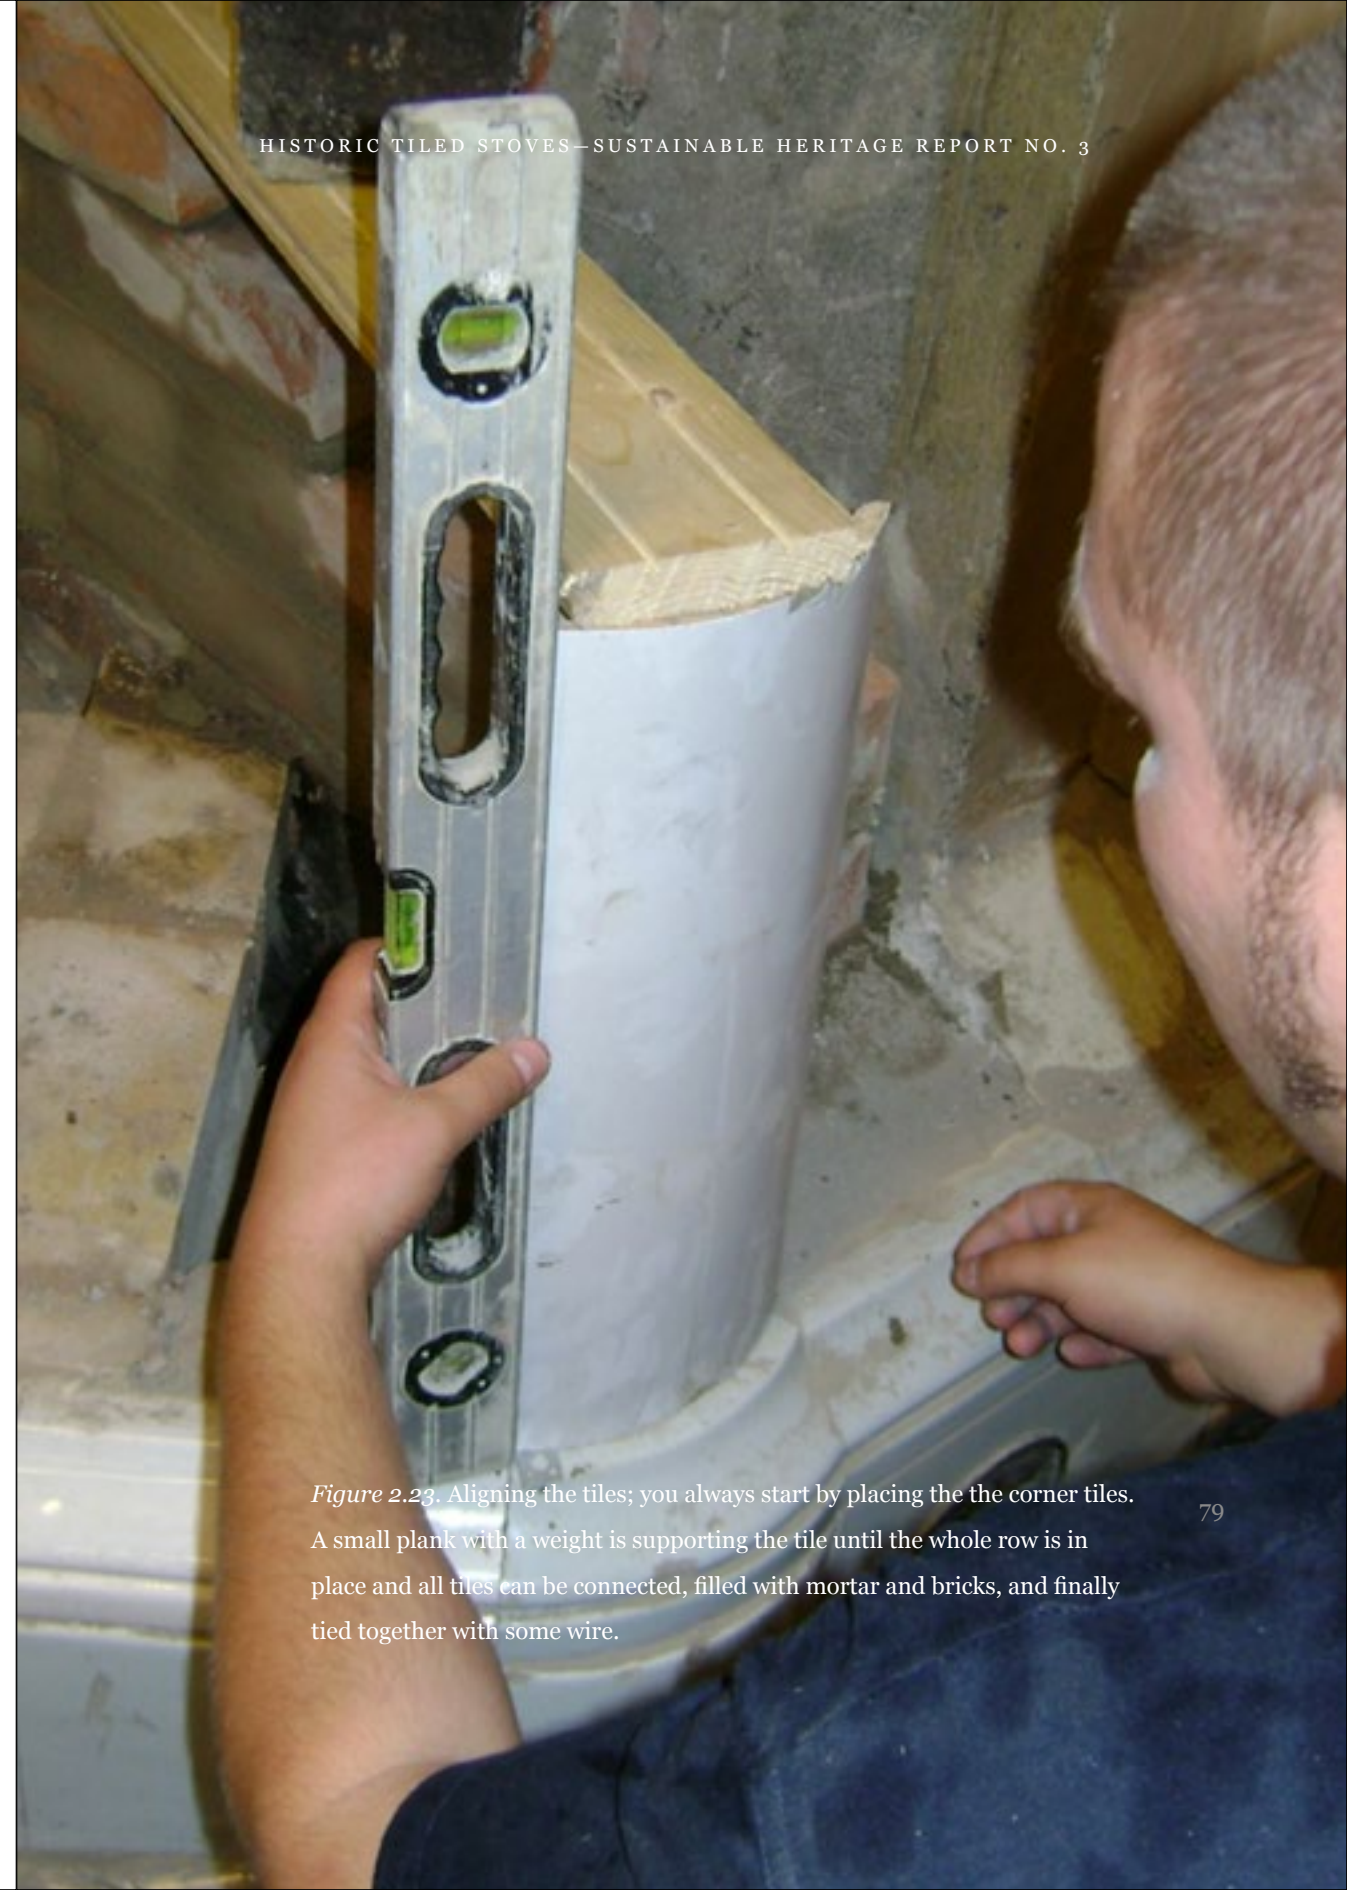
Figure 2.23. Aligning the tiles; you always start by placing the the corner tiles. A small plank with a weight is supporting the tile until the whole row is in place and all tiles can be connected, filled with mortar and bricks, and finally tied together with some wire.

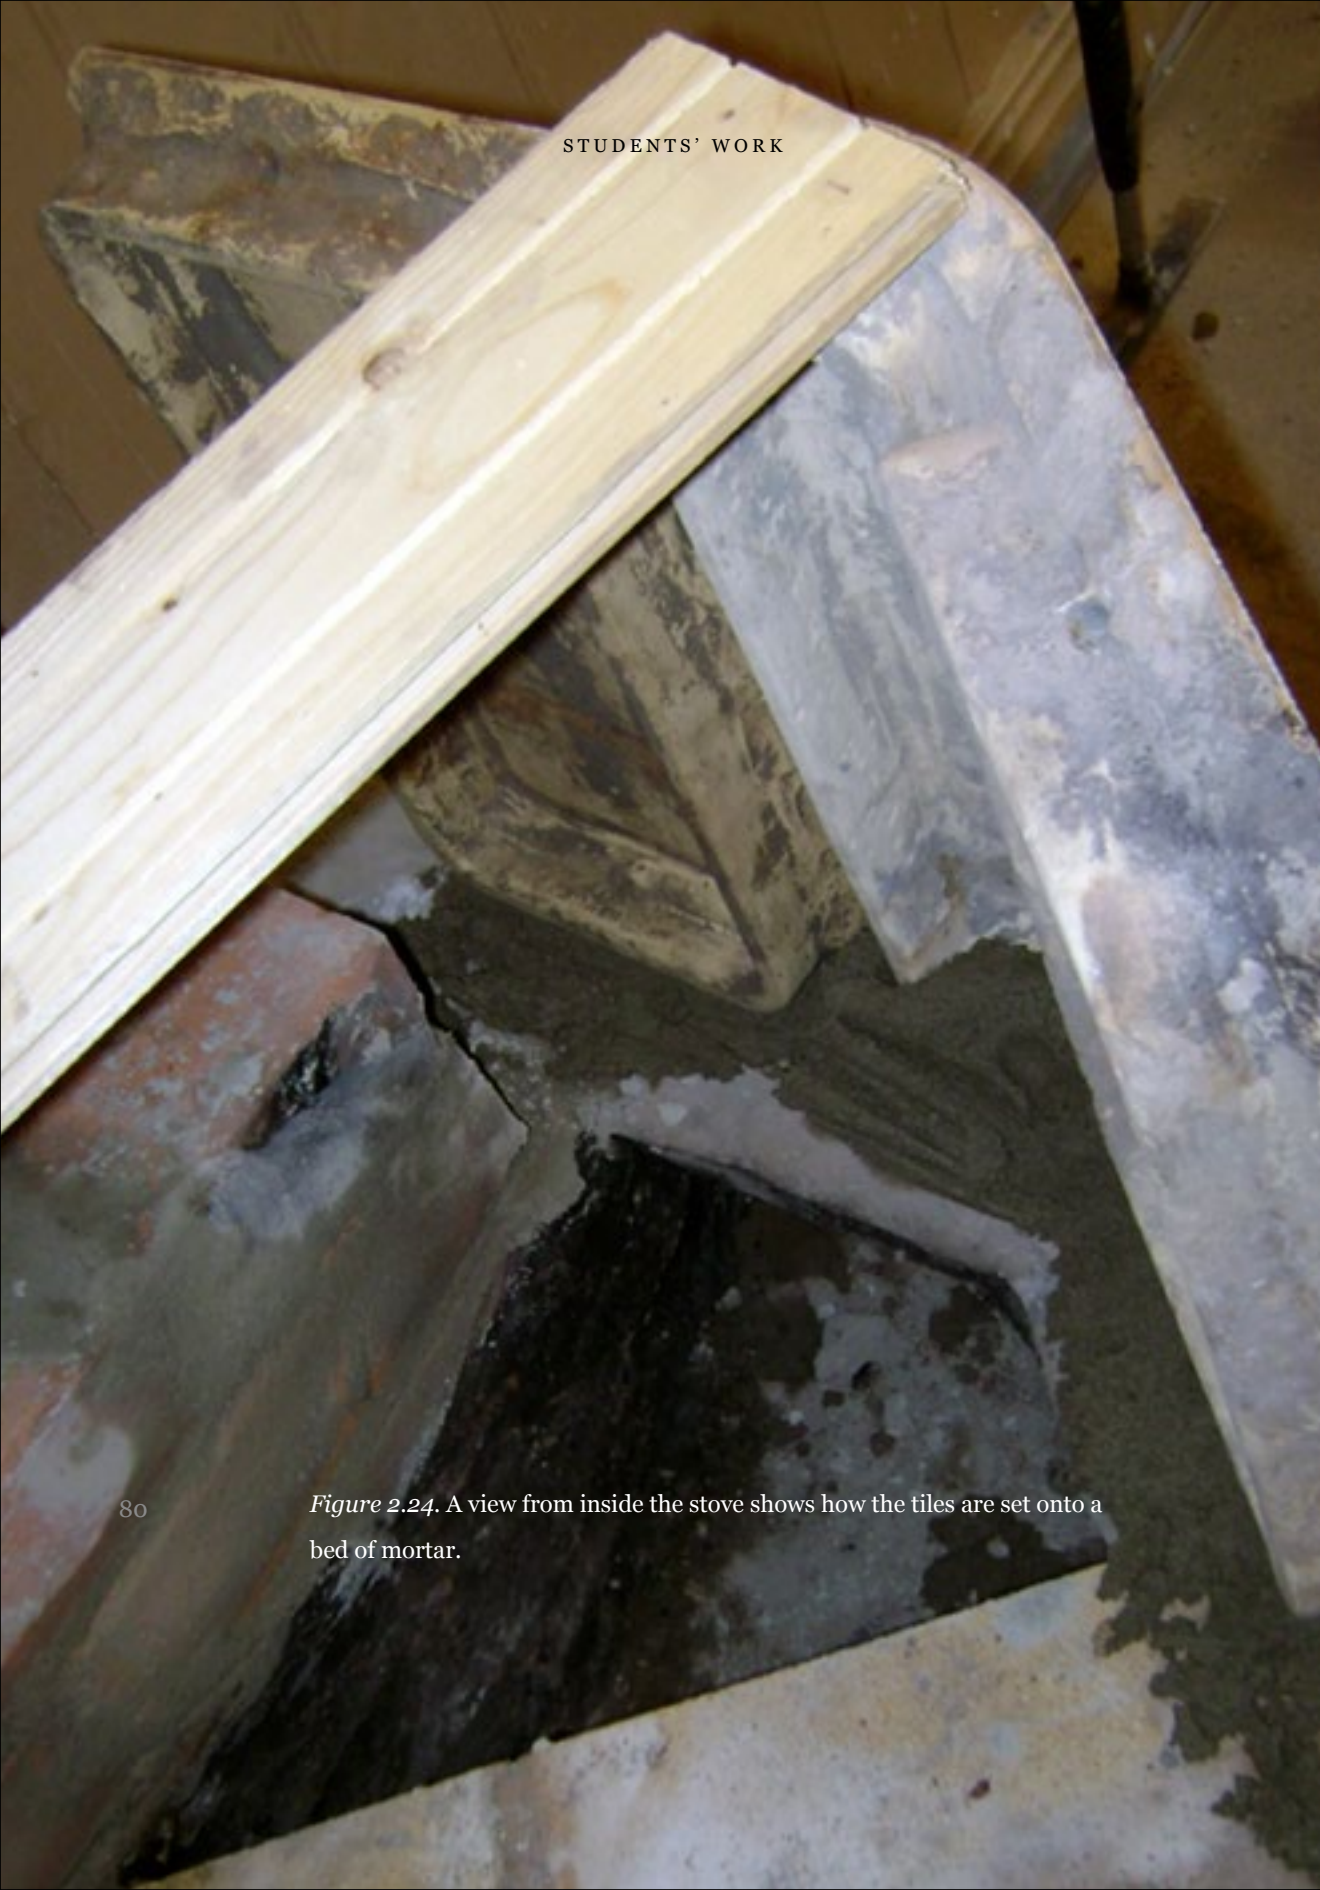
Figure 2.24. A view from inside the stove shows how the tiles are set onto a bed of mortar.

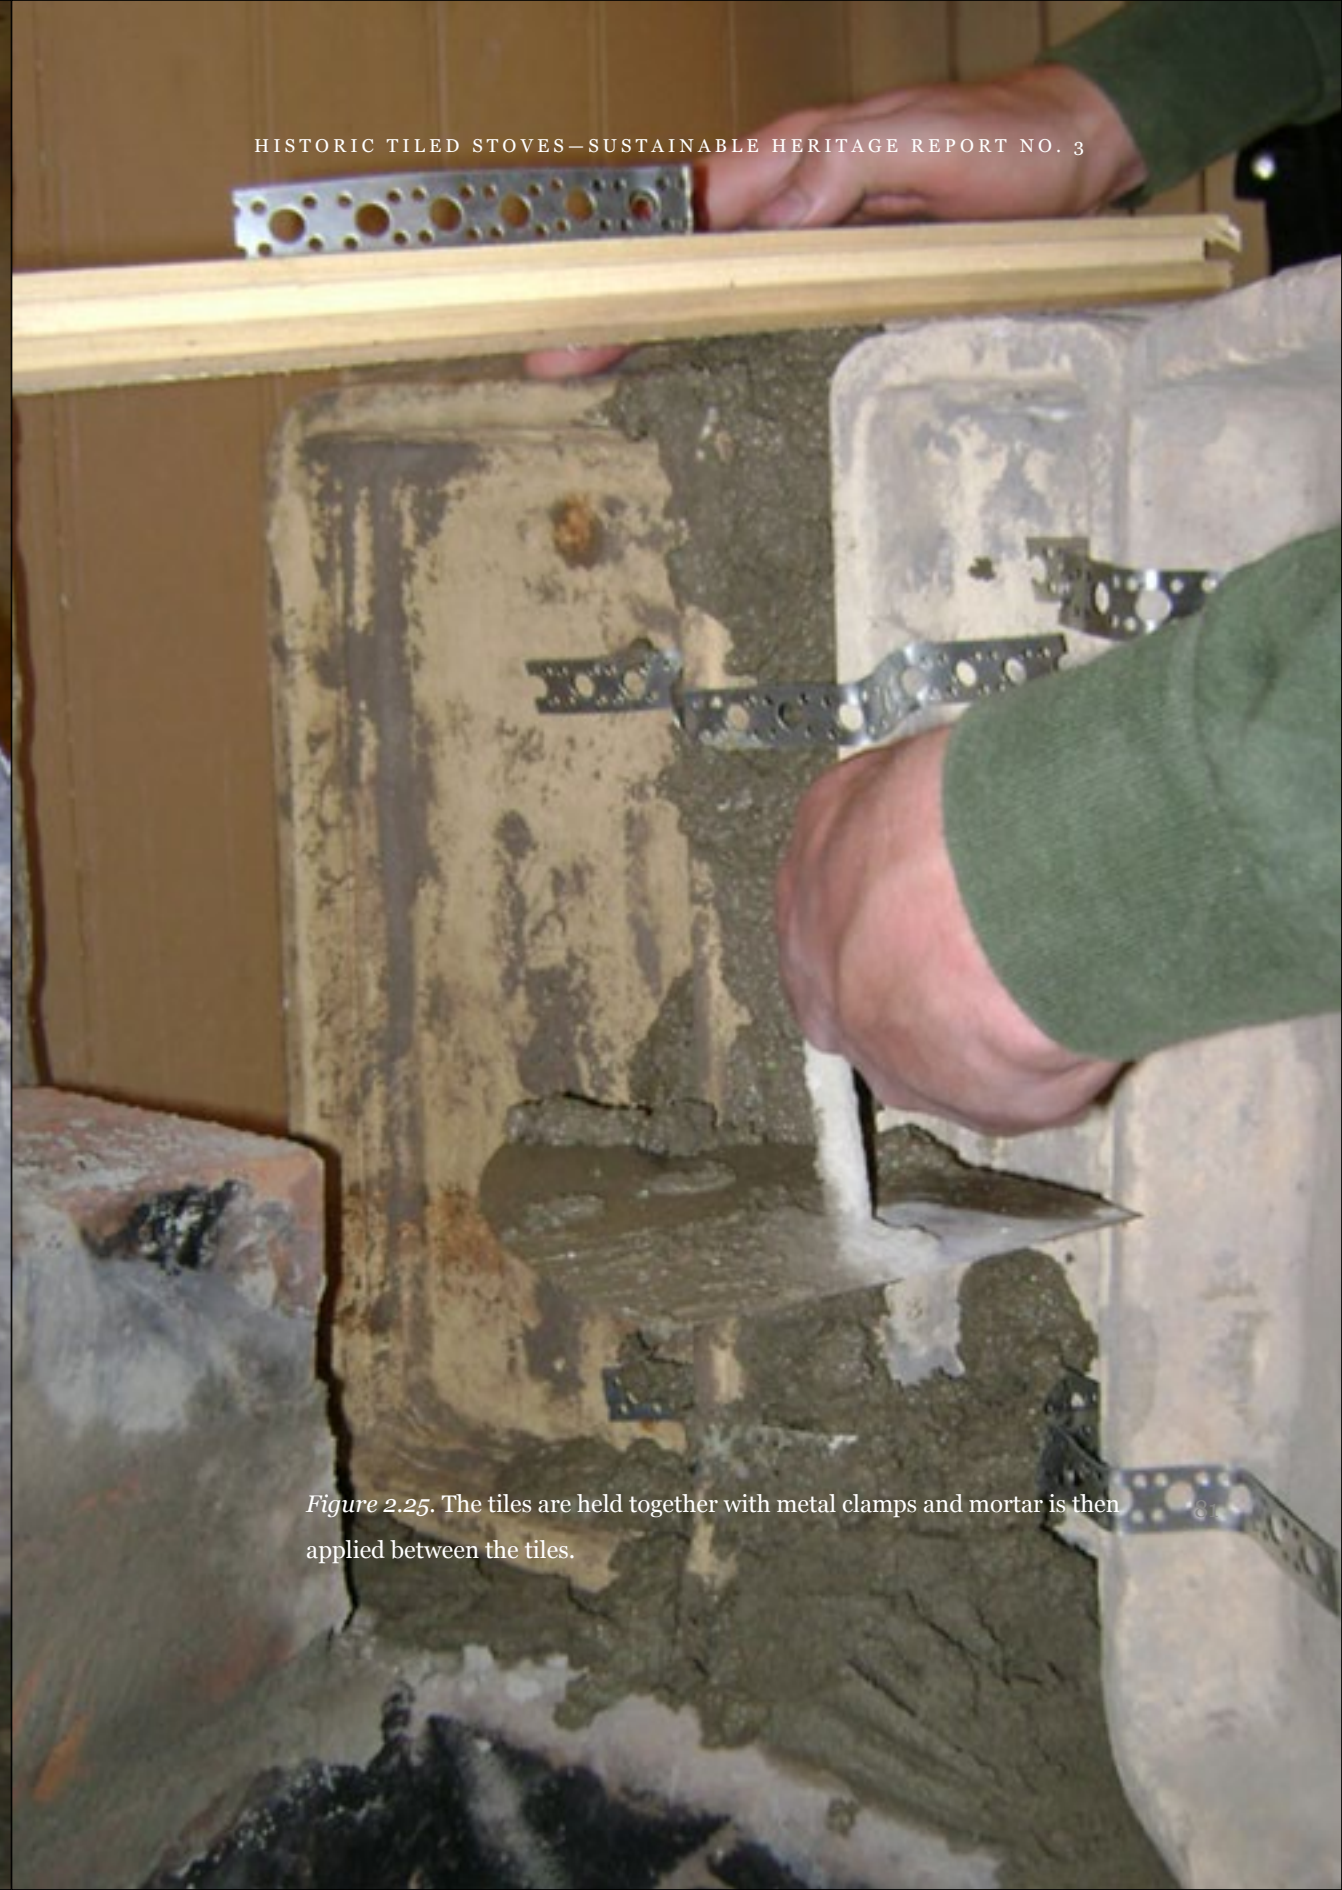
Figure 2.25. The tiles are held together with metal clamps and mortar is then applied between the tiles.

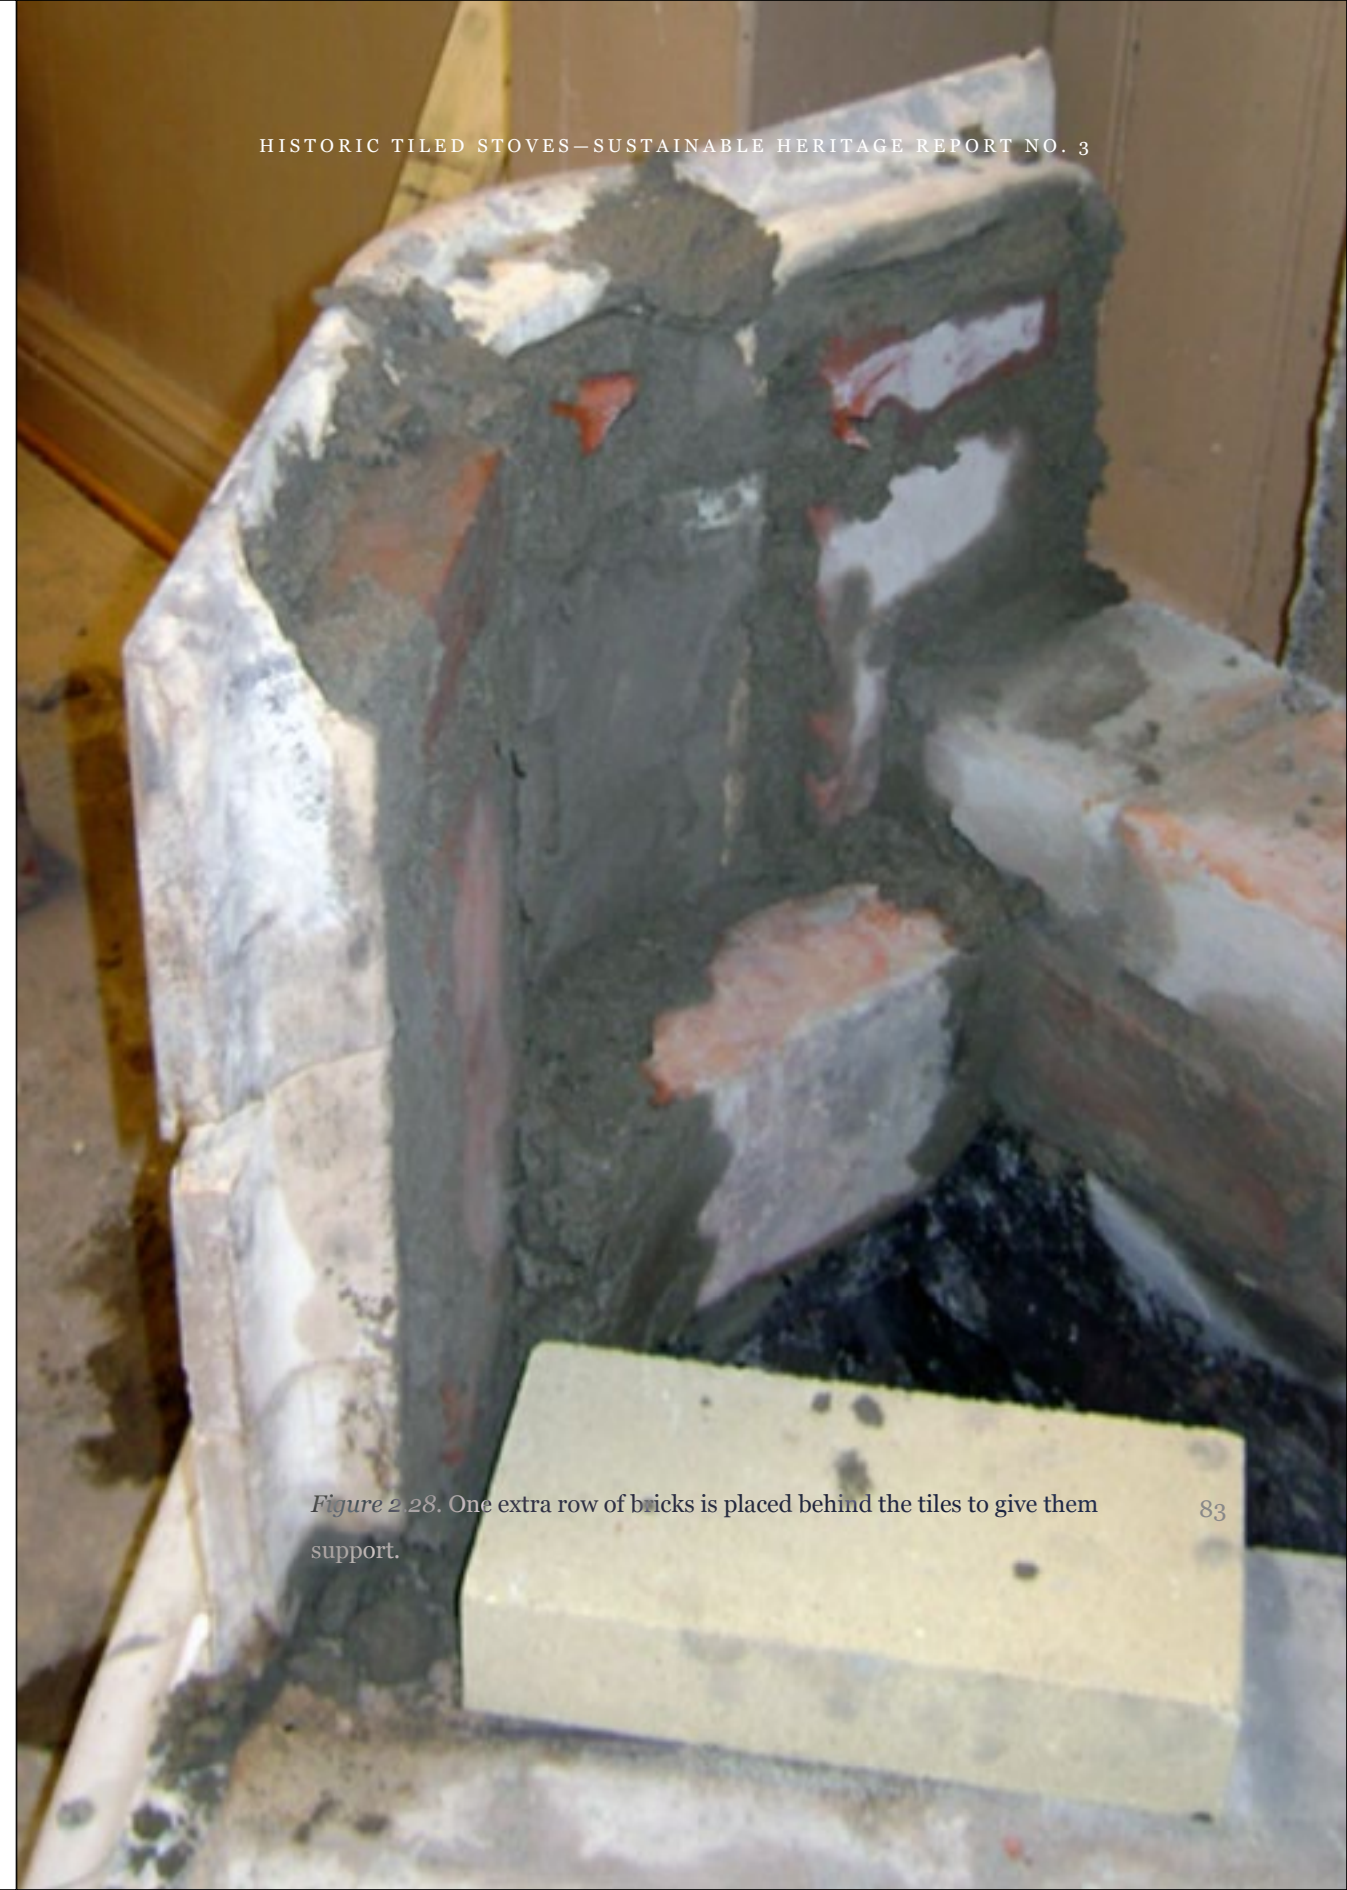
Figure 2.28. One extra row of bricks is placed behind the tiles to give them support.

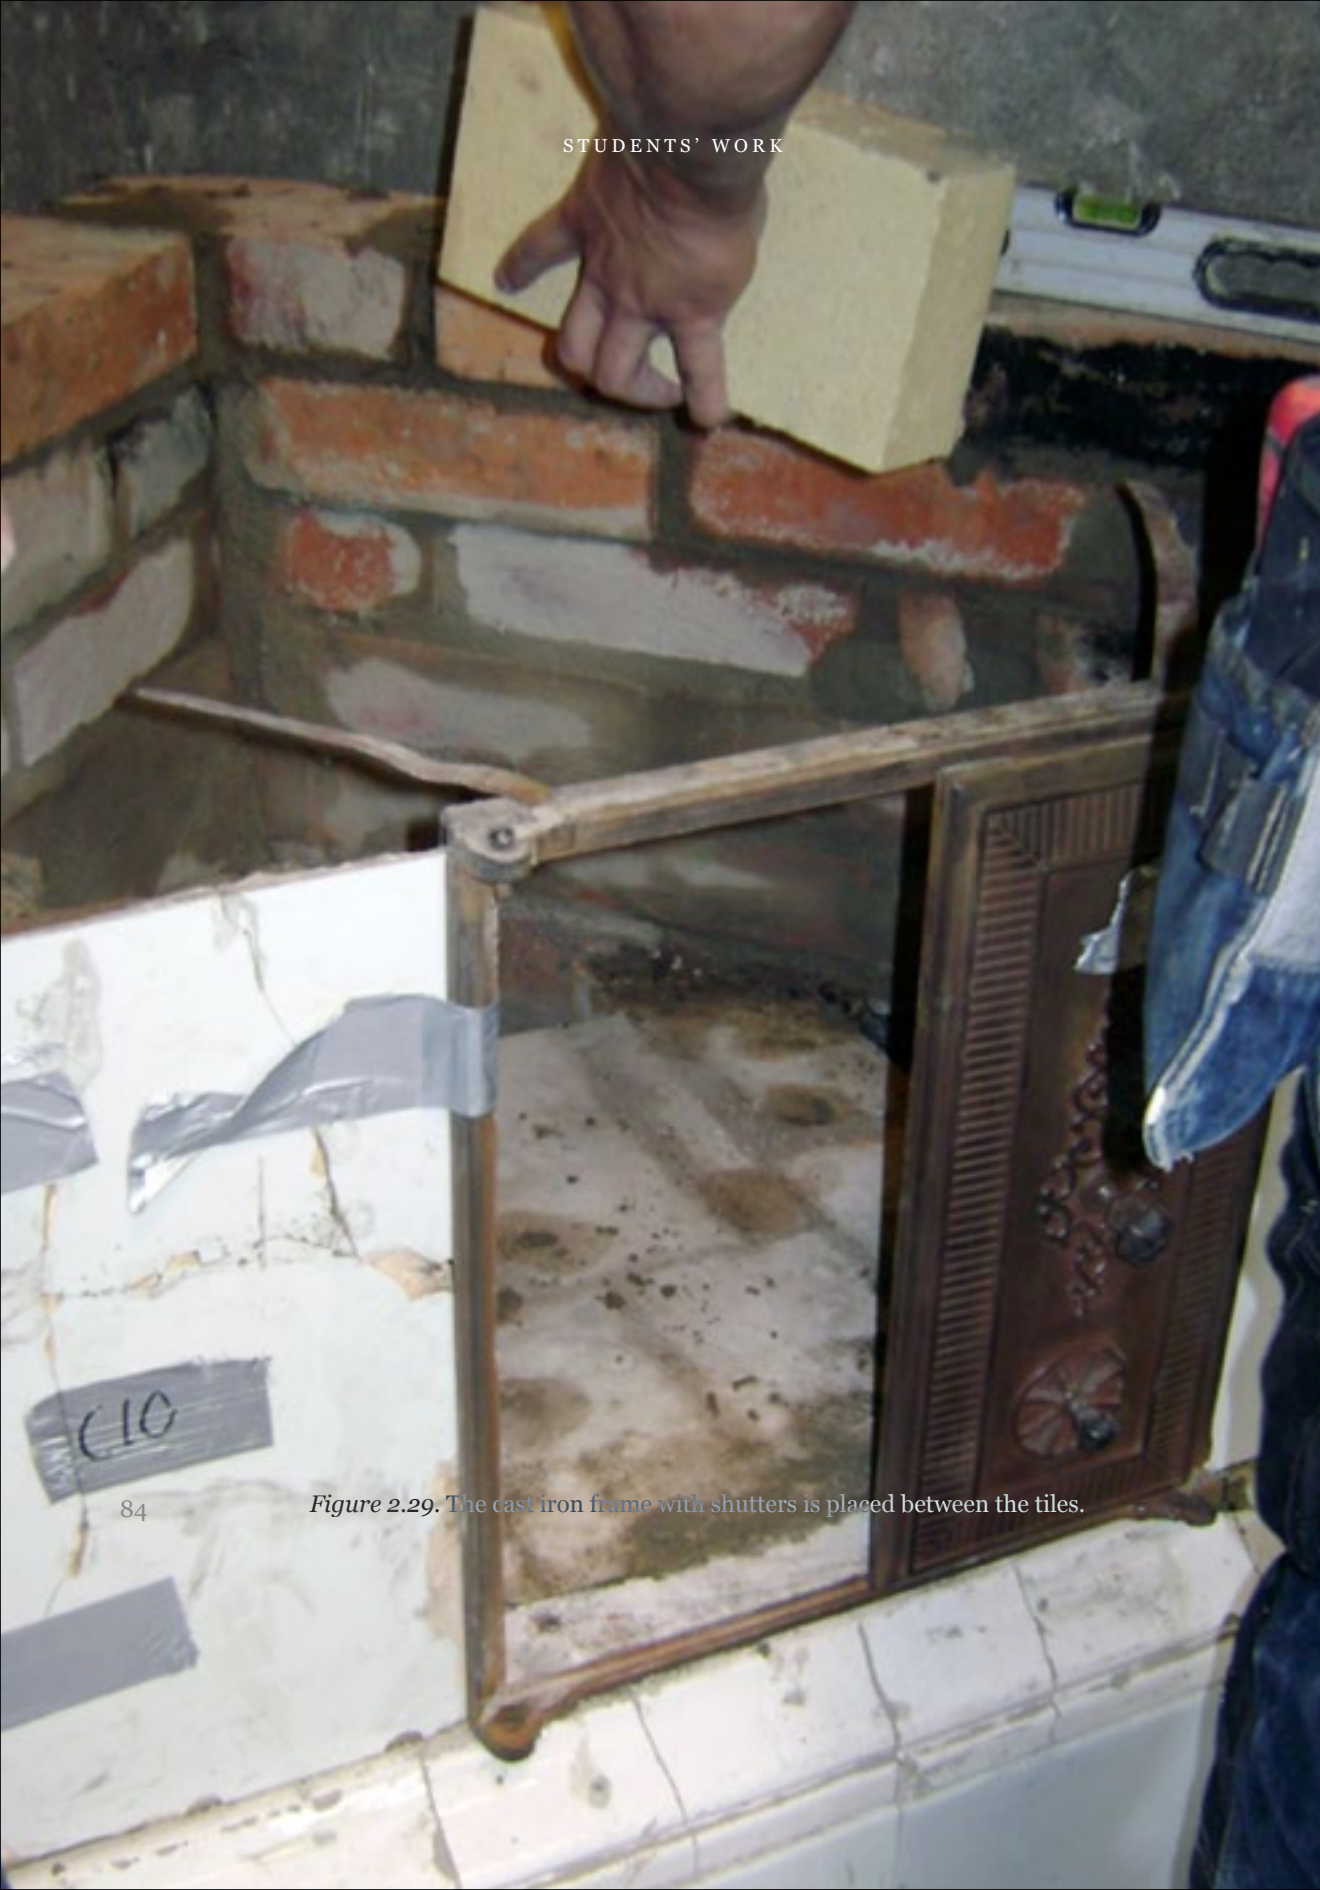
Figure 2.29. The cast iron frame with shutters is placed between the tiles.

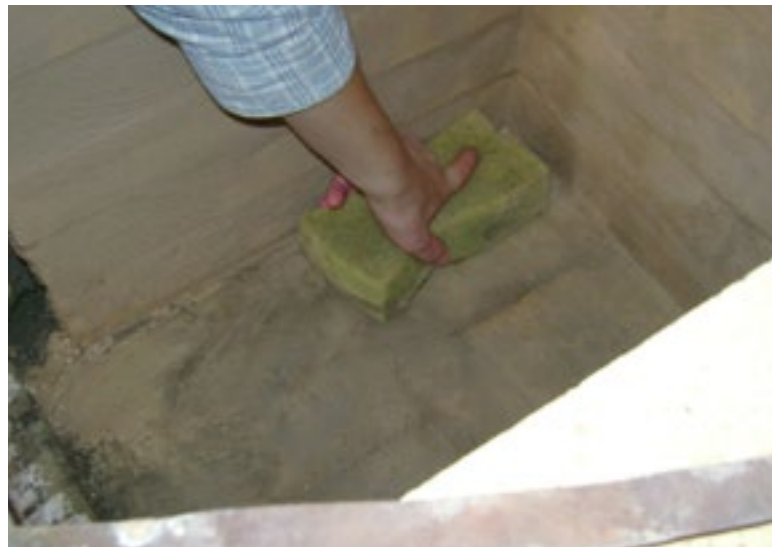
Figure 2.33. The bricks and joints are being washed with a moist sponge.

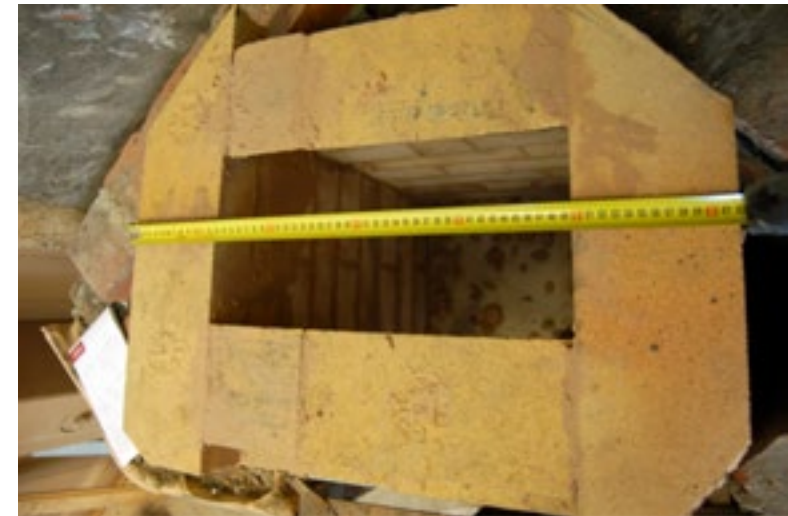
Figure 2.34. The middle flue is narrowed at the back and front of the furnace with a row of bricks that have been shaped with an angle grinder. This bottle neck will improve the draught in the flue.

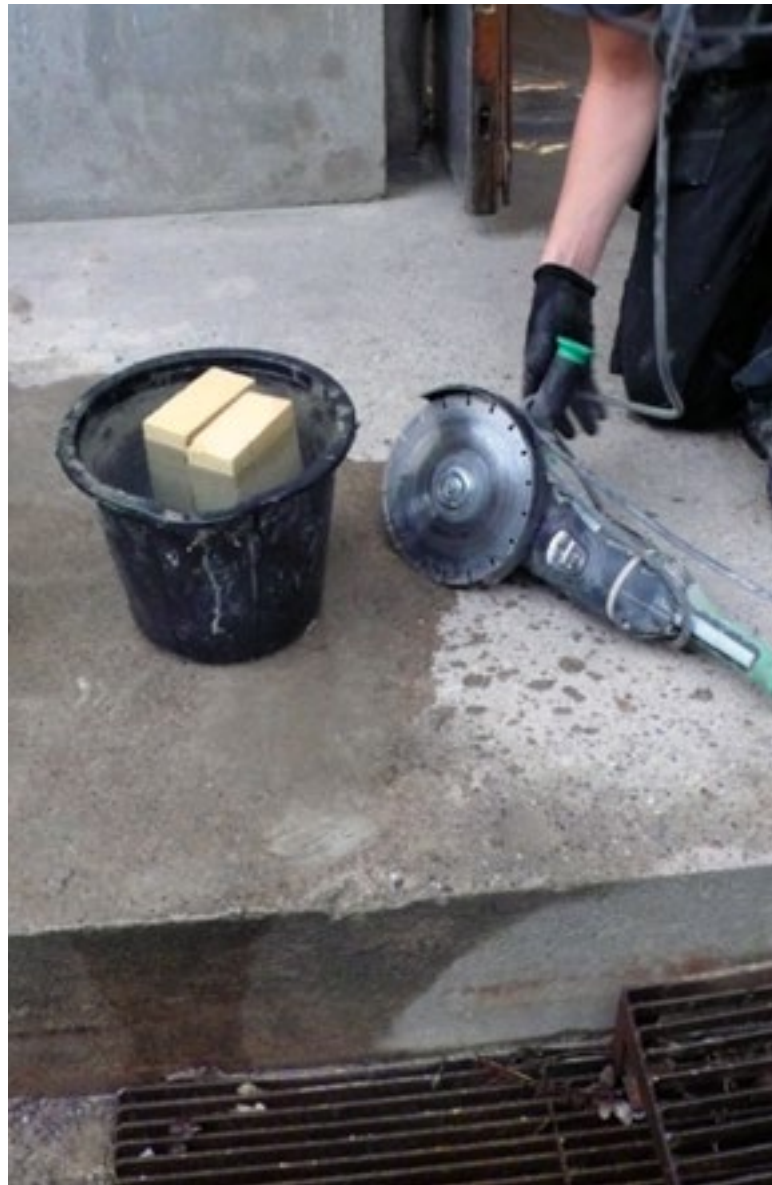
Figure 2.36. Before using the angle grinder the fireproof bricks are hydrated to avoid over-heating the blade.

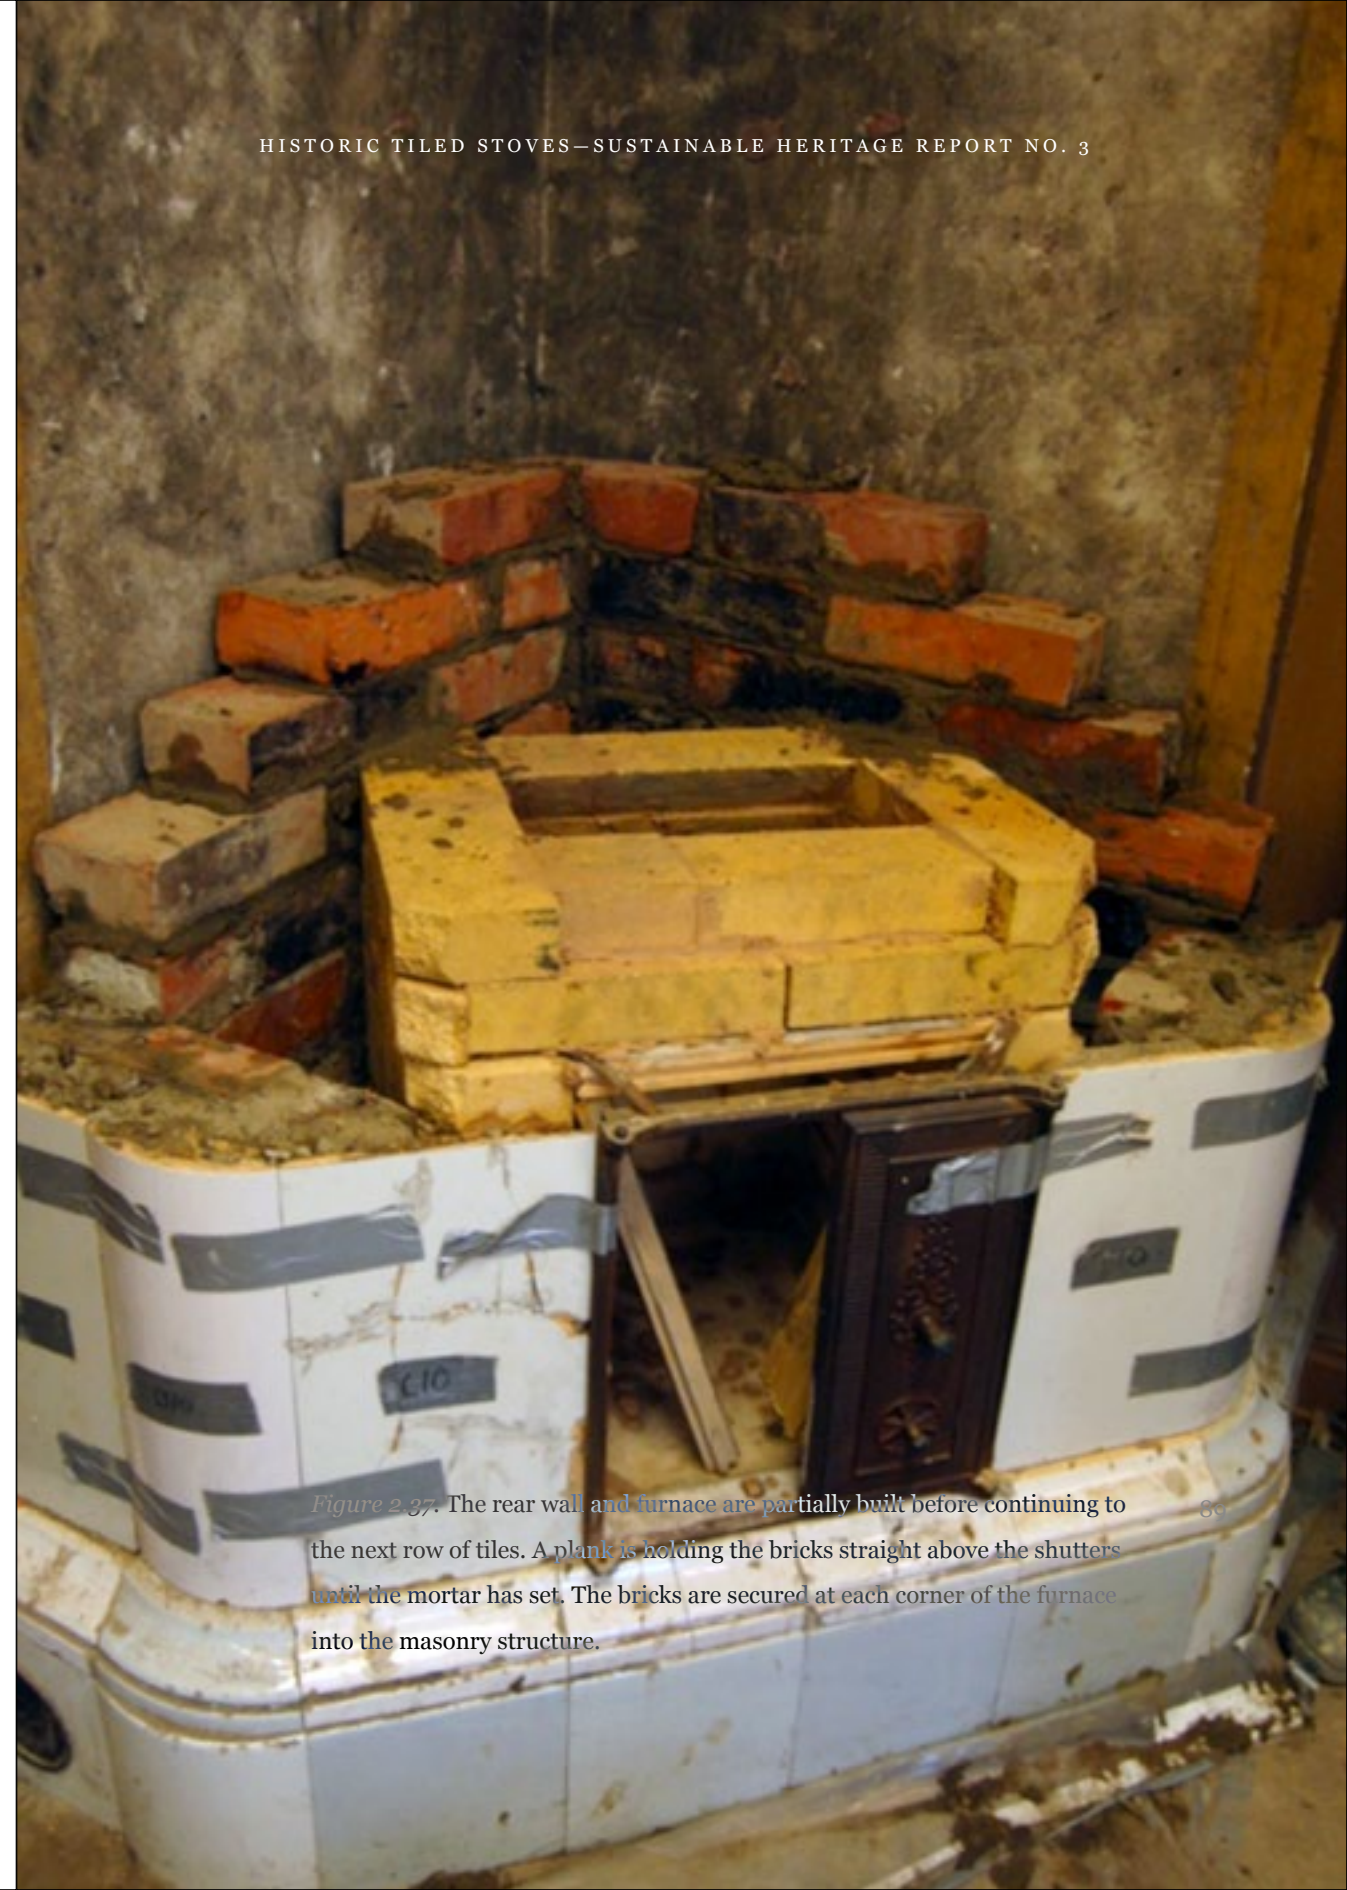
Figure 2.37. The rear wall and furnace are partially built before continuing to the next row of tiles. A plank is holding the bricks straight above the shutters until the mortar has set. The bricks are secured at each corner of the furnace into the masonry structure.

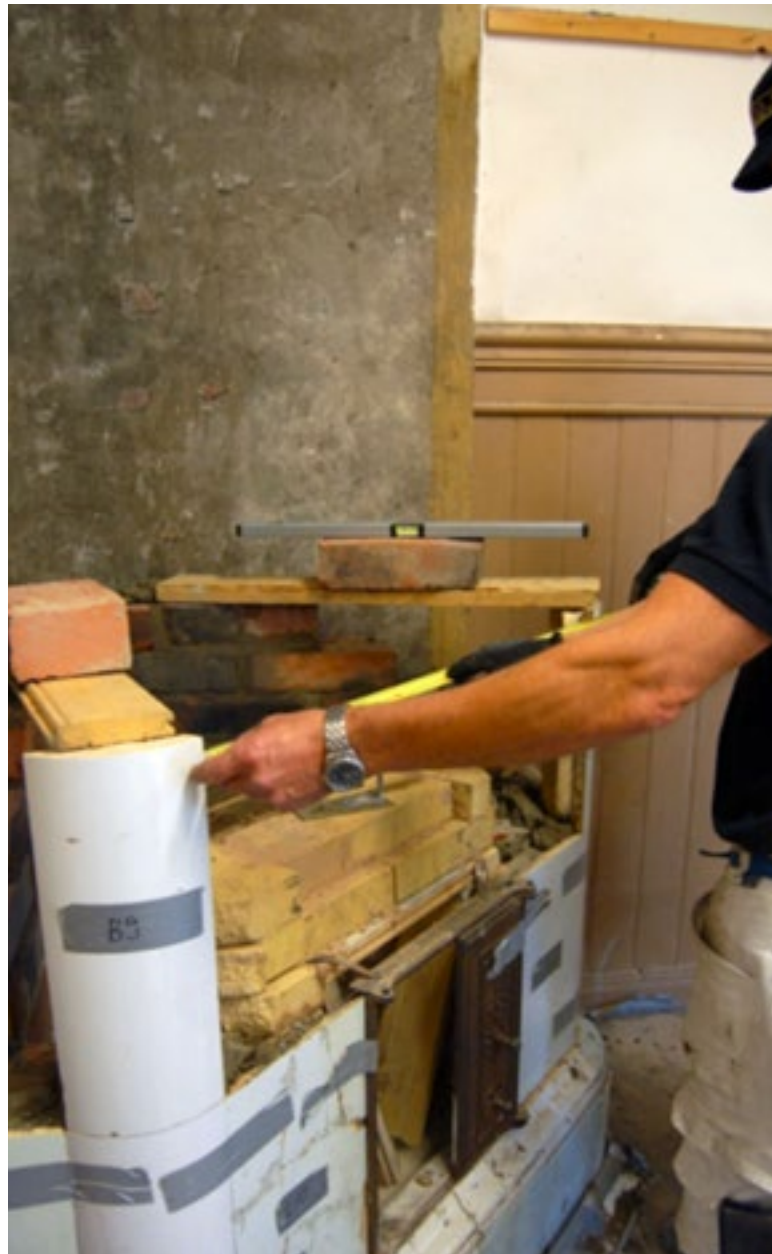
Figure 2.41. When both corner-tiles are in place the distance is double-checked to insure that the centre tiles will fit.
